Modellbeschreibung: **PASSAT Lim. TREND 103 TDID6F**

Service Campaign 23H9

Piezo Pumpe Injector Elements

Release date: 07-Jan-2013

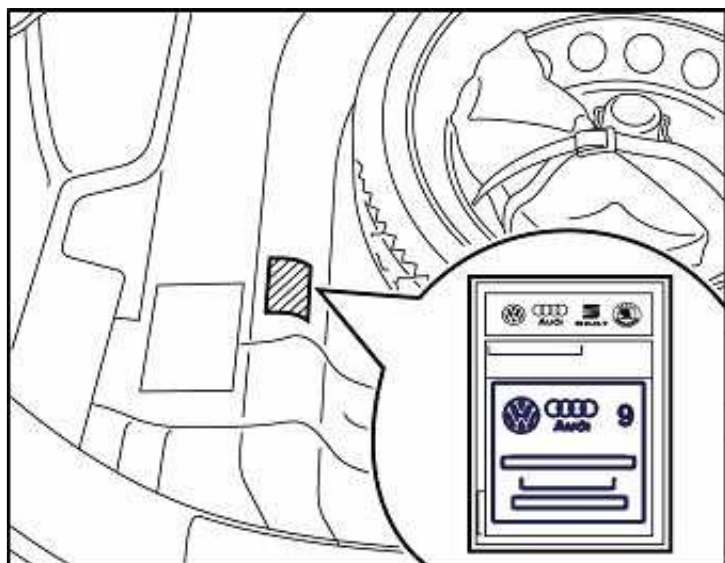
If the vehicle is listed in the systems as **not** completed, check whether a campaign sticker with the entry "**23H9 date/stamp**" is attached in the spare wheel well area (next to *data sticker*):

If the campaign sticker is attached, the campaign has already been performed. Make the entry "**23H9 date/stamp**" in the service schedule under "Space for workshop entries".

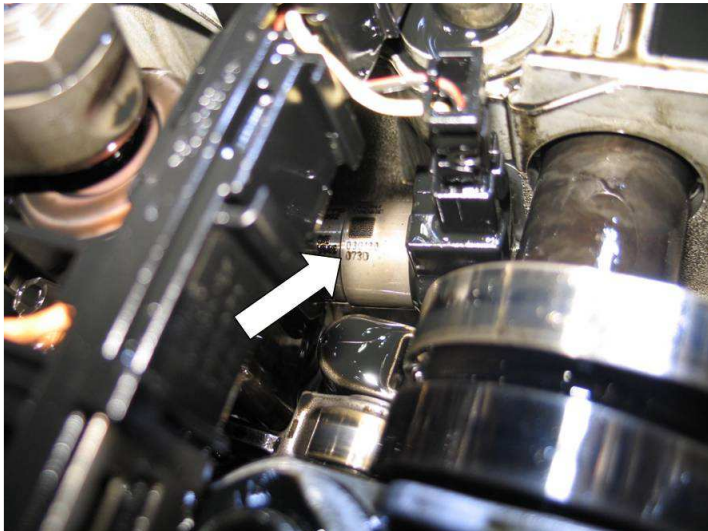
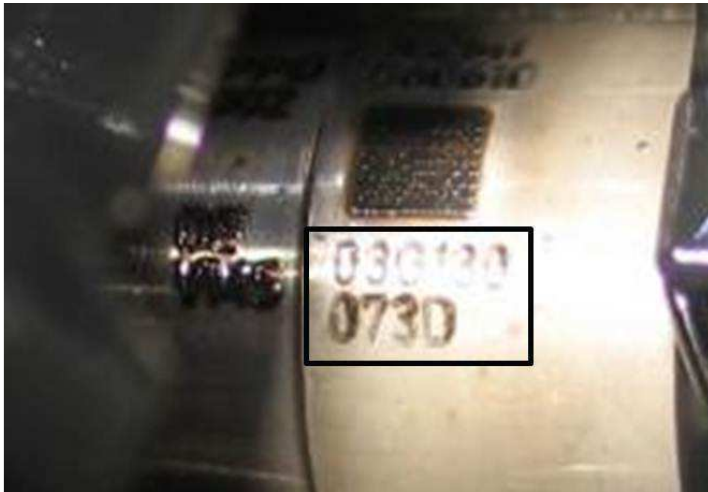
Check the part number -see arrow- on the pump injector element.

All pump injector elements with the part number

- **03G 130 073 D** or
- **03G 130 073 M**

must **be replaced**

=> drive unit, 4 cyl. diesel engine (2.0l, 4 valve), rep. gr. 23 fuel preparation diesel injection, diesel direct injection system, remove and install pump injector unit.

To prevent renewed resistance, replace the wiring loom for the pump-injector units in addition to the pump-injector units.
